ROOF SYSTEM

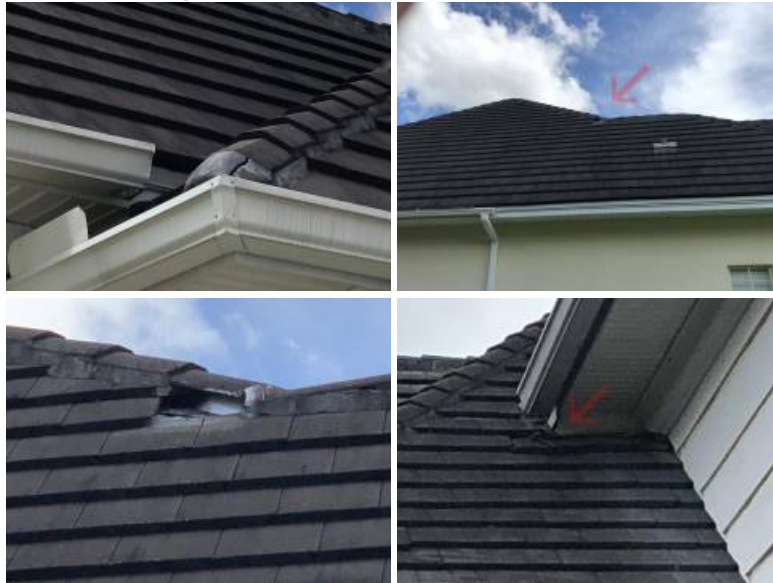
Roof Tiles

Concrete on front left corner of tile roof is cracked and deteriorated. Maintenance and repair by a qualified tradesperson recommended. Roof tile(s) missing or displaced - Left side of structure. Recommend evaluation and repair by a licensed roofing contractor. Roof tiles displaced - front of structure. Recommend evaluation and repair by a licensed roofing contractor.
