## HEATING & AIR CONDITIONING

### Downstairs Air Conditioning System

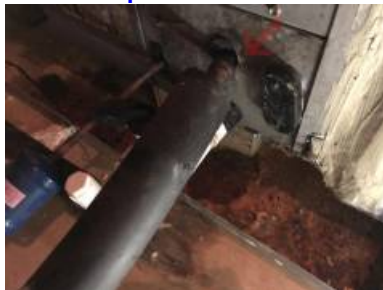
<b>A/C System Condition(s)</b>	<b>A/C system copper line set insulation terminates short of the air handler. Exposed portions of the copper refrigerant line have a tendency to sweat during hot weather, when the system is operating frequently. Maintenance and repair is needed to prevent moisture stains or damage to interior ceilings and/or walls.</b>
