# INTERIOR

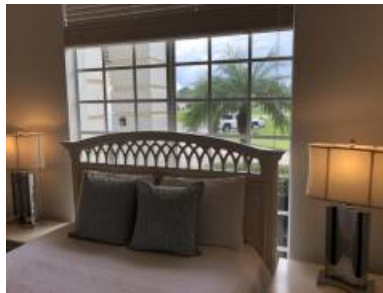
<b>Windows</b>	<b>Downstairs front left bedroom window does not open. This is considered to be a safety hazard. All living area rooms require a secondary means of egress. Suggest evaluation by a qualified tradesperson for appropriate improvements and corrections.</b>
----------------	--
