## POOL/HOT TUB & EQUIPMENT

### Pool Equipment

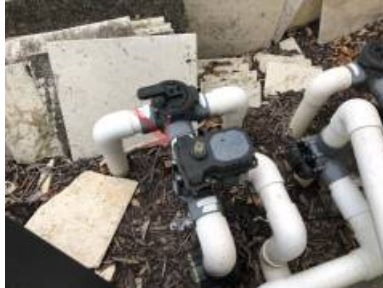
**Pool Plumbing**

**Swimming pool plumbing ball valve handle(s) broken. Upgrade recommended.**

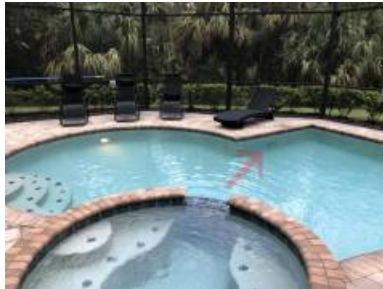
**Pool Light**

**Swimming pool right side light fixture did not respond at time of inspection. I recommend evaluation by a qualified tradesperson for appropriate corrections and improvements.**
