STRUCTURE

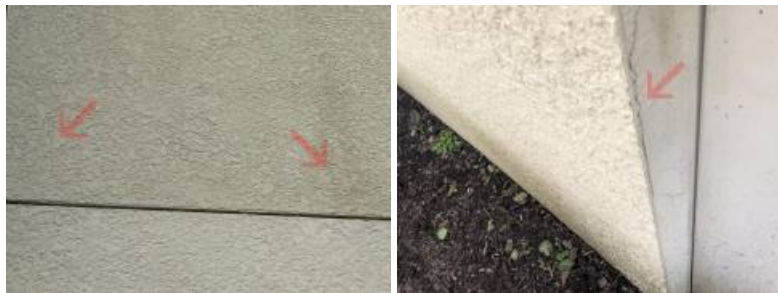
Concrete Block - Down. Wood Frame - Up. Stucco Finish.
Exterior wall structure appears to be in satisfactory condition.
Hairline crack(s) observed in the stucco finish. Crack(s) should be sealed to eliminate the threat of water intrusion.

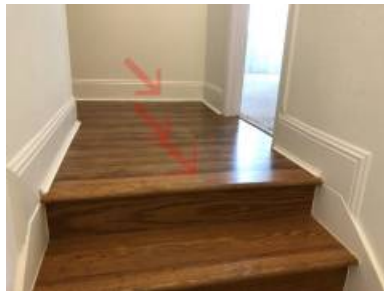
Exterior trim appears to be in satisfactory condition.
Concrete slab appears to be in satisfactory condition.
Second story floor structure at the top of stair landing is not level. Alteration has been made to the second floor in this area. Open living area has been converted to a bedroom and bathroom. Uneven floor does not appear to be a structural issue. Recommend contacting qualified contractor if questions remain about uneven floor.
