BATHROOMS

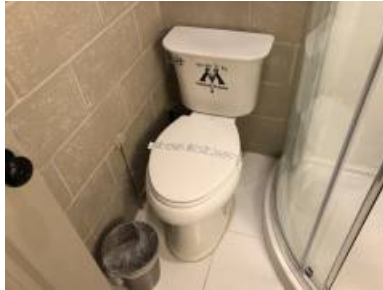
Downstairs Jack and Jill bathroom toilet is loose at floor, allowing it to wobble or spin. Maintenance and repair needed to restore proper operation and prevent possible leakage.

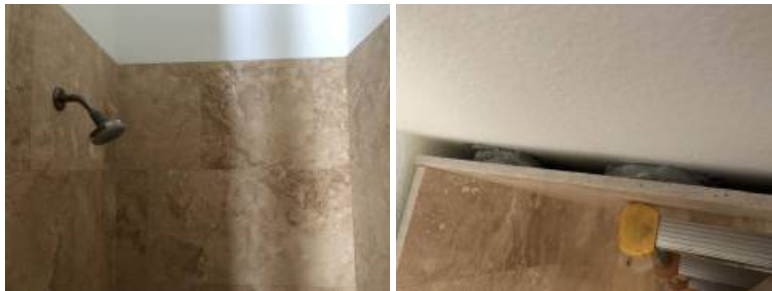
Master bathroom shower wall tile(s) are loose or hollow. Shower tile installation is unprofessional. Evaluation and repair by a qualified tradesperson recommended.
